## INSTABILITY OF MULTISTAGE COMPRESSOR K1501

Zhou Ren-mu  
 Hangzhou Steam Turbine Works  
 Hangzhou Zhejiang, People's Republic of China

This paper primarily discusses the failure and the remedy described above.

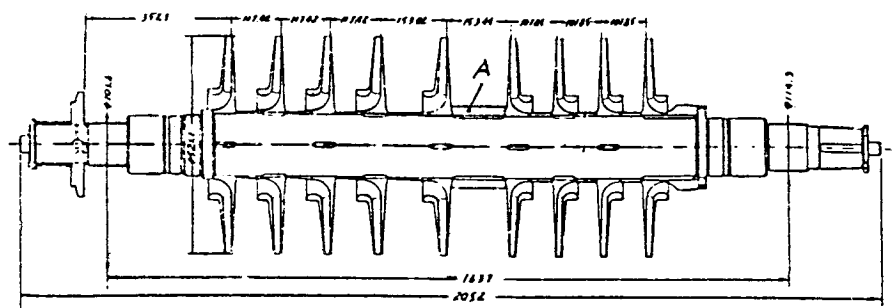
Figure 2. - Rotor of K1501LP.

Intensive vibration originated from the low-pressure compressor, K1501LP. Figure 2 shows the longitudinal section of its rotor. Table I shows the parameters of the tilting pad of both bearings. Figure 3 shows the gas labyrinth construction of the middle diaphragm. Figure 4 provides a critical speed map and mode shapes for the rotor.

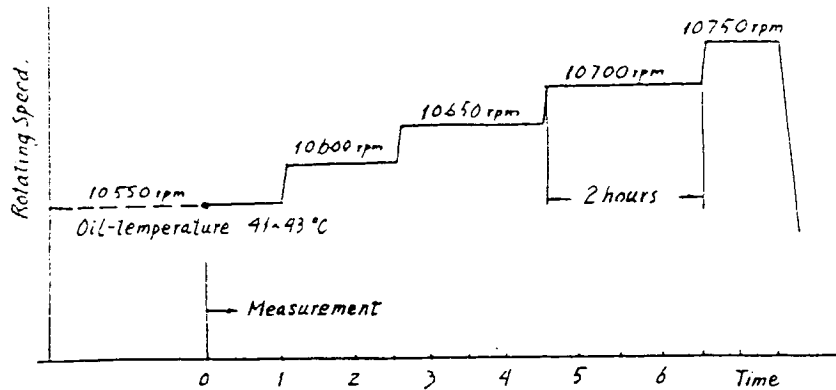
Figure 11. - Test procedure for November 8, 1983.

To eliminate the vibration failure rapidly, we cooperated with Mitsubishi in completing a series of tests on November 5-8, 1983. The test speeds were to 10 222 rpm on the first day, and to 10 550 rpm on the third day. All the tests were within specifications. The test procedure for the fourth day is shown in figure 11. After reaching 10 750 rpm and running for an hour, the shaft vibrated intensely.
